PLIDCO® **SPLIT+REPAIR ELL** **SPLIT+REPAIR TEE &** **SPLIT+REPAIR CROSS**

Capable of Repairing Pipe Fittings and Angled Pipe Sections

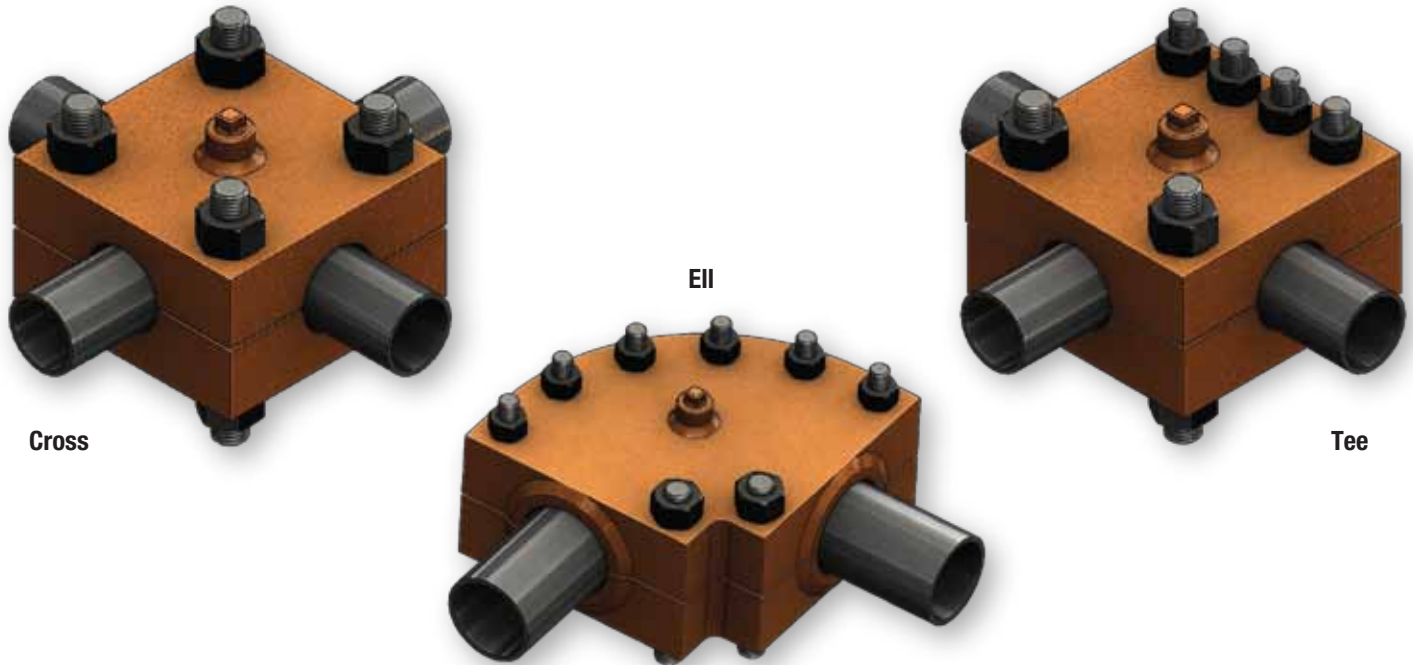
The PLIDCO® Split+Repair Ell and the PLIDCO® Split+Repair Tee and the PLIDCO® Split+Repair Cross fittings are safe and reliable as well as easy and quick to install. They have steel GirderRing to hold the seals in place and protect them from displacement and damage during installation. Once the fitting is bolted properly to the line the leak is contained. There is no need for shutdown while the leak is being repaired. Depending on the size and pressure it may be necessary to add clamping ends to resist unbalanced forces and/or customer specified forces. PLIDCO® Split+Repair Ells, Tees, and Crosses can be welded for a permanent repair while the line is in service. If used as a temporary fitting and not welded to the line, any one of these options can be removed and sent back to the factory to be reconditioned, and then returned to your inventory.

The PLIDCO® Split+Repair Ell is available in many configurations including 45°, 90°, short radius, long radius, long radius with tangents, as well as screwed and socket welded and custom sizes and angles.

The PLIDCO® Split+Repair Tee and PLIDCO® Split+Repair Cross are manufactured to customer specifications.
